INDOOR AIR QUALITY ASSESSMENT

**Falls Elementary School
One Jackson Street
North Attleborough, MA 02760**

Prepared by:
Massachusetts Department of Public Health
Center for Environmental Health
Emergency Response/Indoor Air Quality Program
June 2005

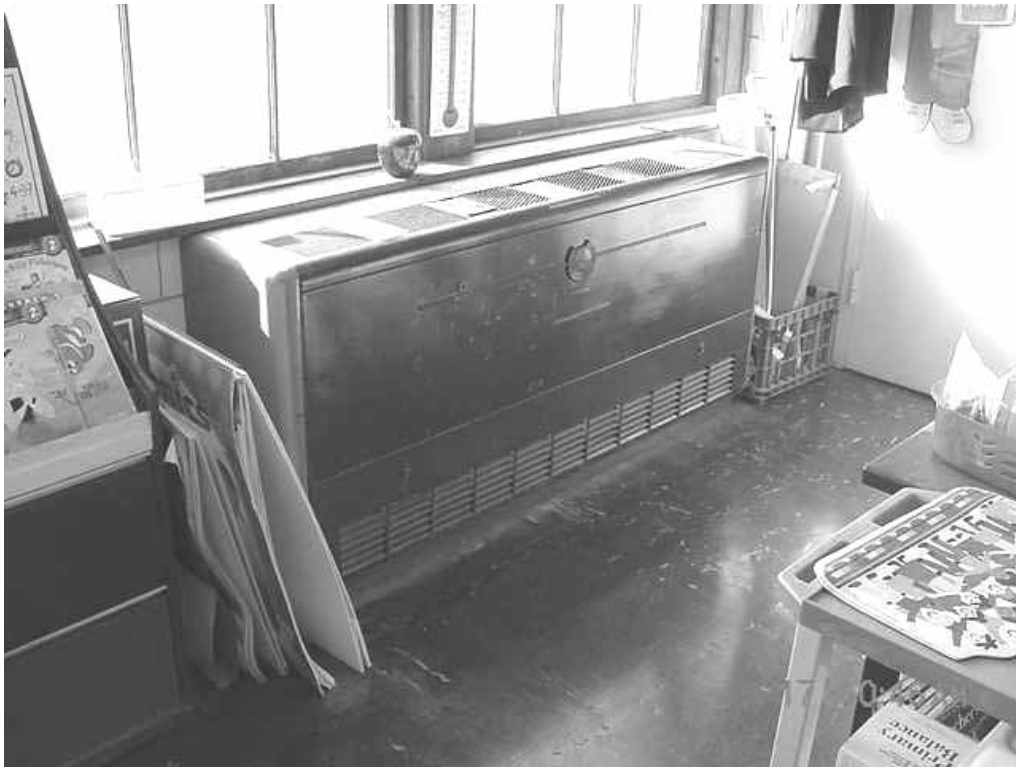
Picture 1

Classroom Univent in Original Portion of the Building (1940's Vintage)

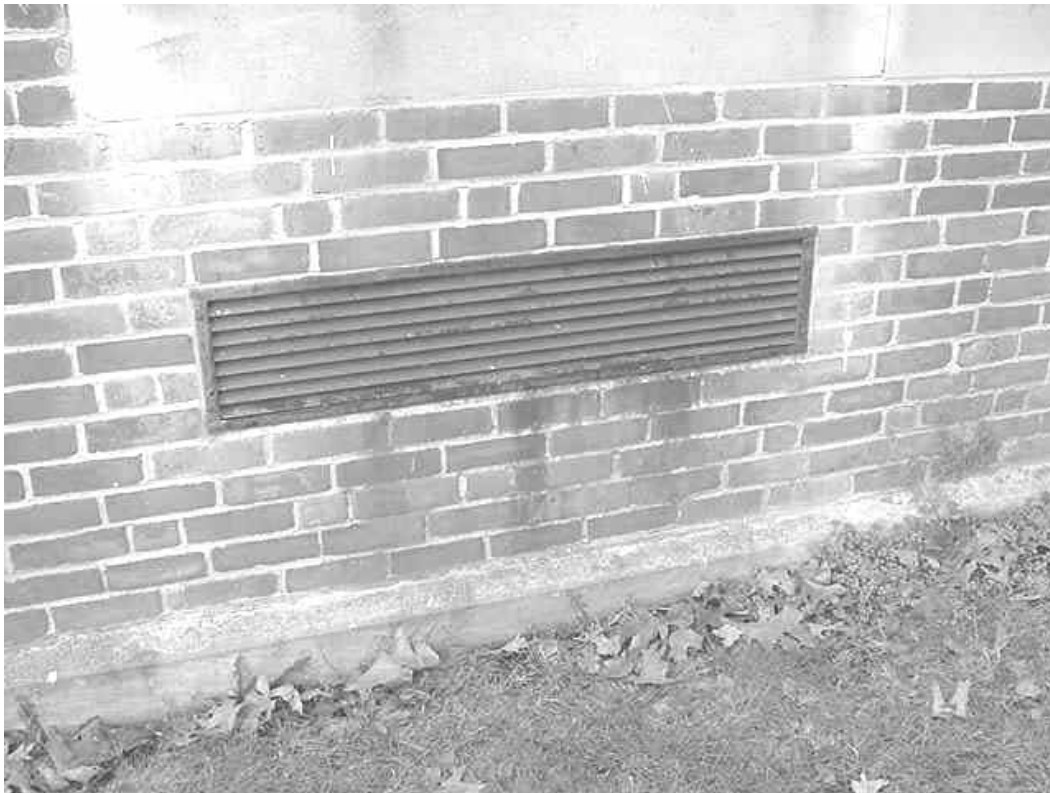
Picture 2

Univent Fresh Air Intake

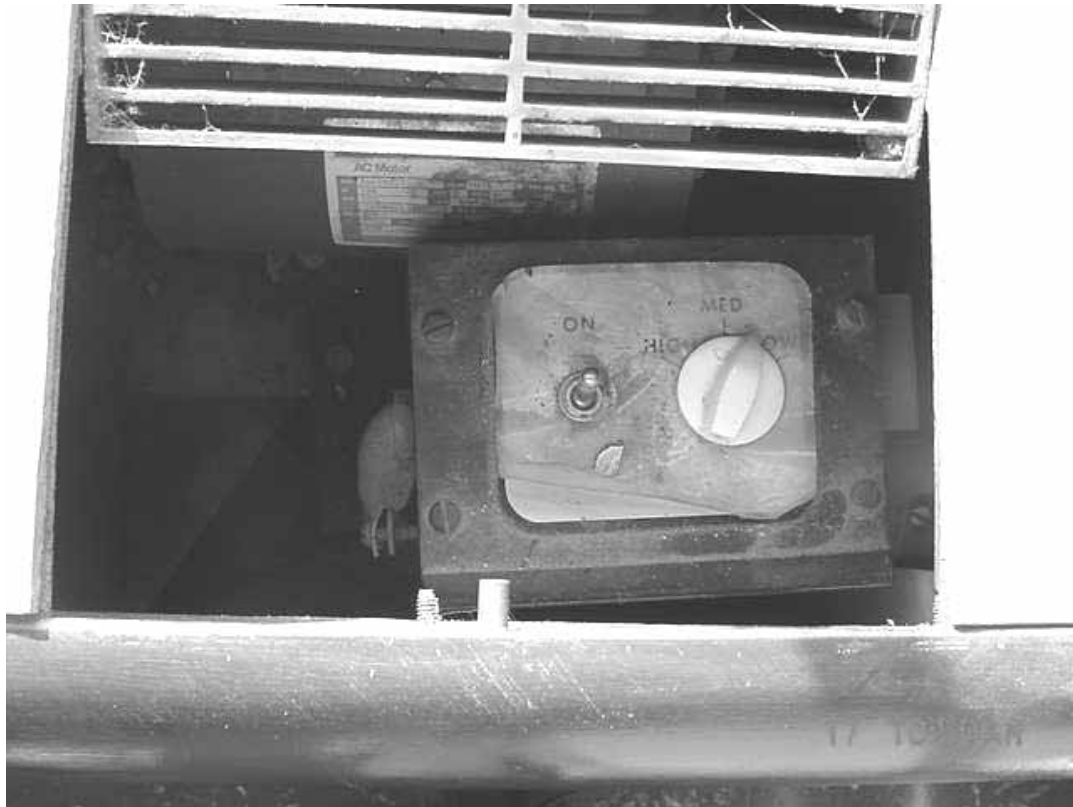
Picture 3

high to adjust fan speed (Picture 3). Obstructions to airflow, such as papers and books stored on univents and bookcases, carts and desks in front of univent returns, were seen in a few classrooms. In order for univents to provide fresh air as designed, units must remain free of obstructions.

Univent Control Panel, Note Fan Speed Dial on Right

independent of thermostat control. To increase airflow in classrooms, set univent controls to “high”.

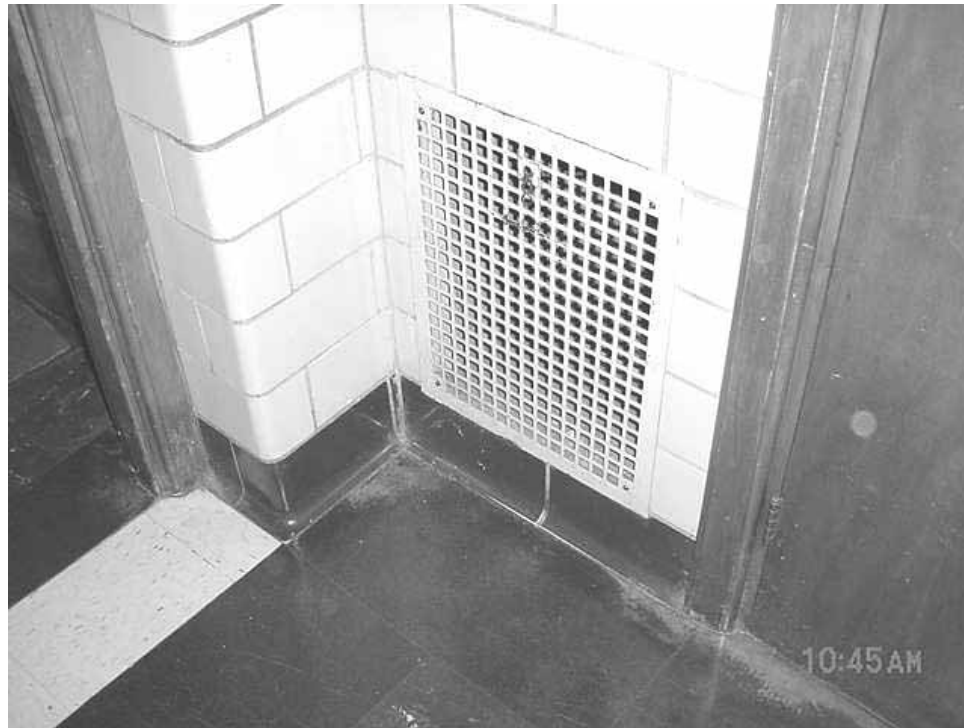
Picture 4

Exhaust ventilation in classrooms is provided by ducted, grated wall vents (Pictures 4 and 5) powered by rooftop motors. Exhaust vents in the 1949 portion of the building are equipped with a pull chain that adjusts a flue inside the vent (Picture 6). No exhaust vents were operating during the assessment, indicating that motors were deactivated or non-functional. As previously mentioned, a number of the exhaust motors had been replaced but were not wired at the time of the assessment. A number of exhaust vents were also obstructed by desks, bookcases and other items (Picture 7). As with the univents, in order to function properly, exhaust vents must be activated and remain free of obstructions. In addition, the location of some exhaust vents can limit exhaust efficiency. In several rooms, exhaust vents are located near hallway doors. When these classroom doors are open exhaust vents become blocked (Picture 8). Exhaust vents in these rooms will also tend to draw air from both the hallway and the classroom reducing the effectiveness of the exhaust vent to remove common environmental pollutants.

Classroom Exhaust Vent in 1949 Portion of the Building

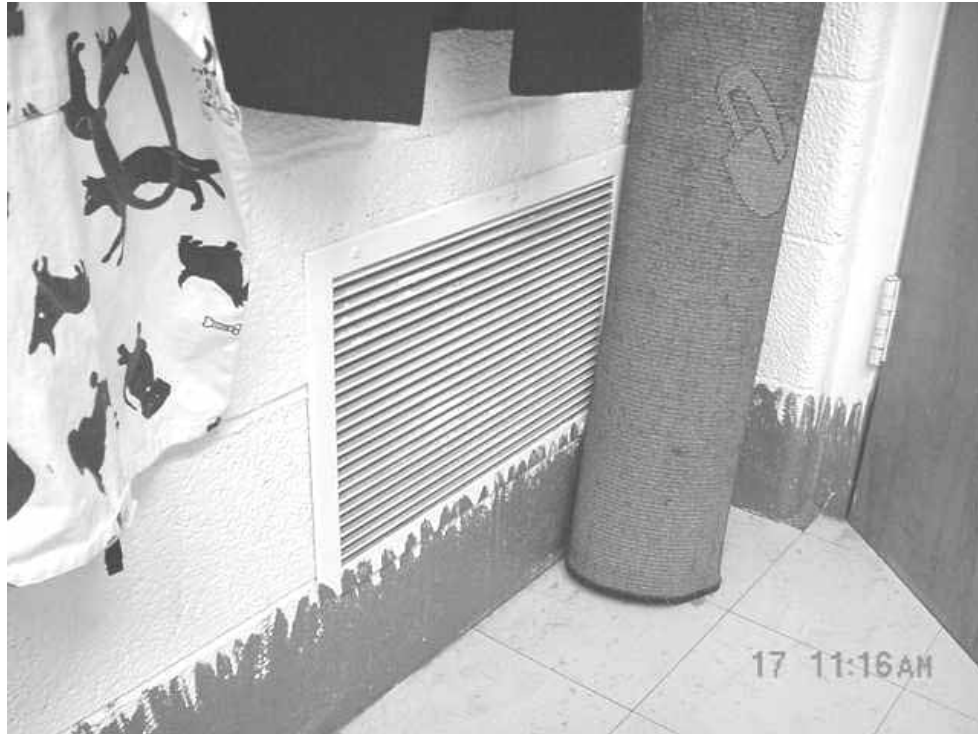
Picture 5

Wall-Mounted Exhaust Vent in Addition Classroom

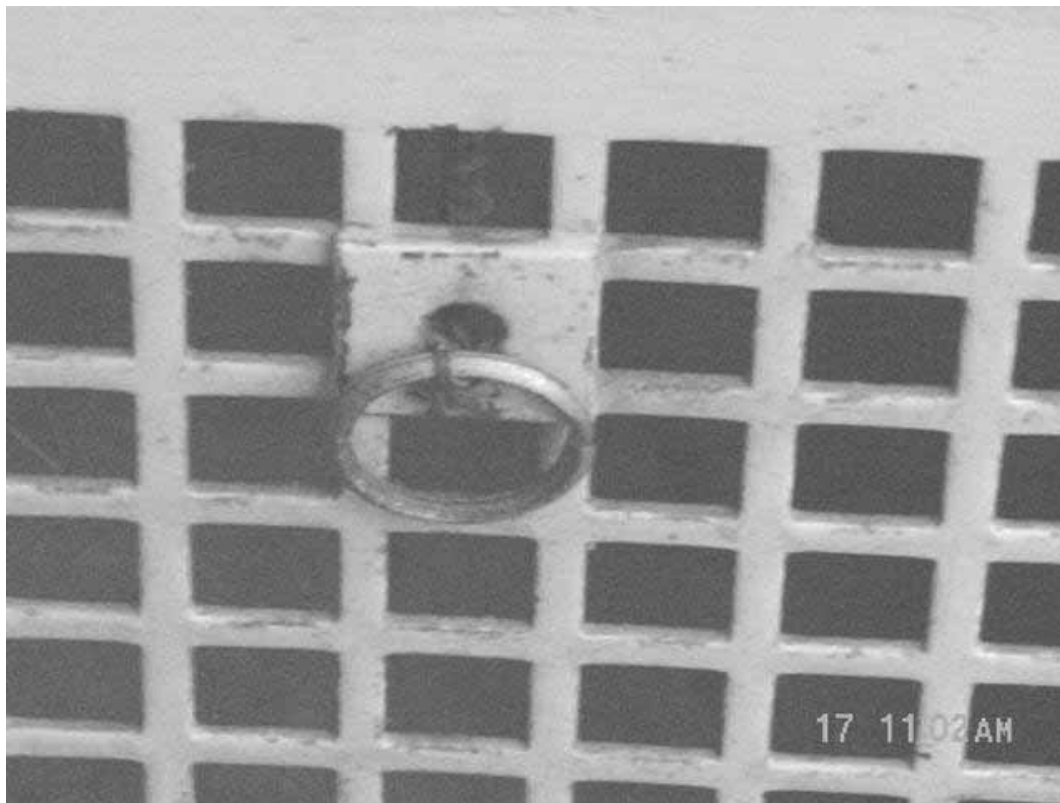
Picture 6

Close-Up of Exhaust Vent Pull Chain in 1949 Classrooms

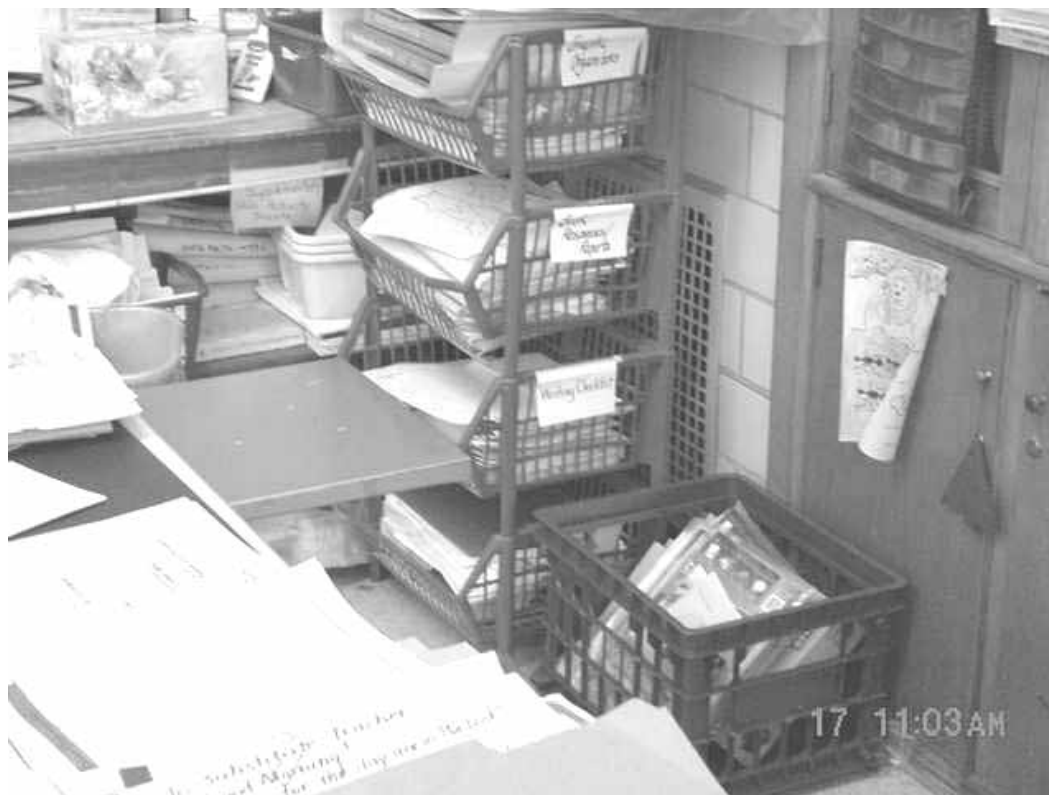
Picture 7

Obstructed Classroom Exhaust Vent

5. Remove all blockages from univents and exhaust vents to ensure adequate airflow.
6. Close classroom doors to facilitate air exchange via the mechanical ventilation system.

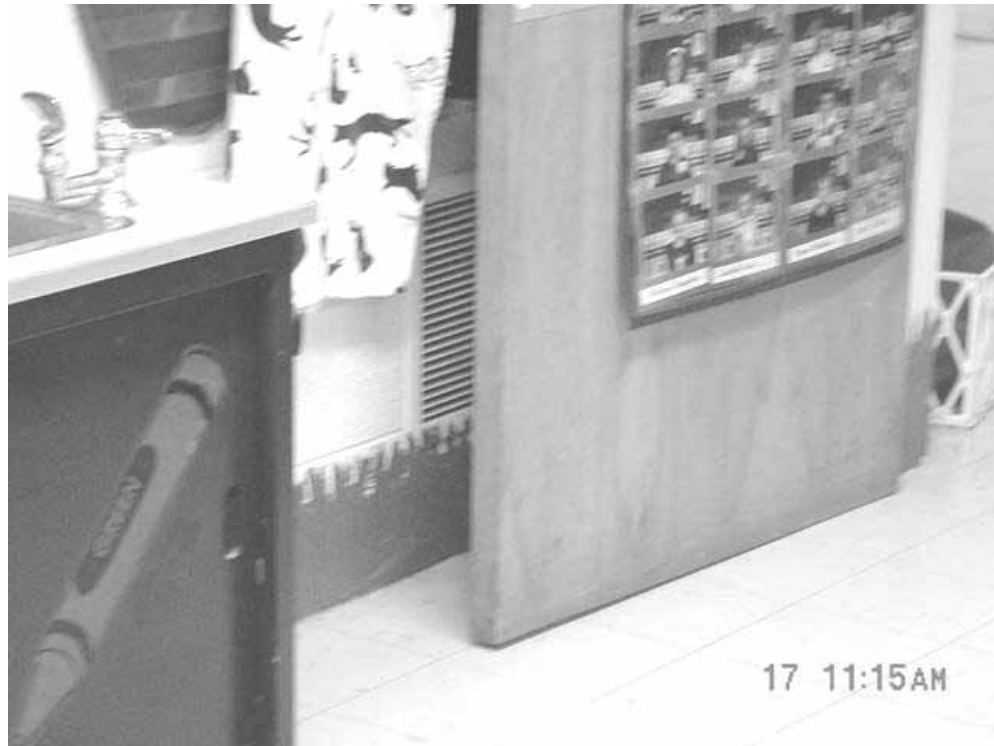
Picture 8

Classroom Exhaust Vent Obstructed by Open Hallway Door

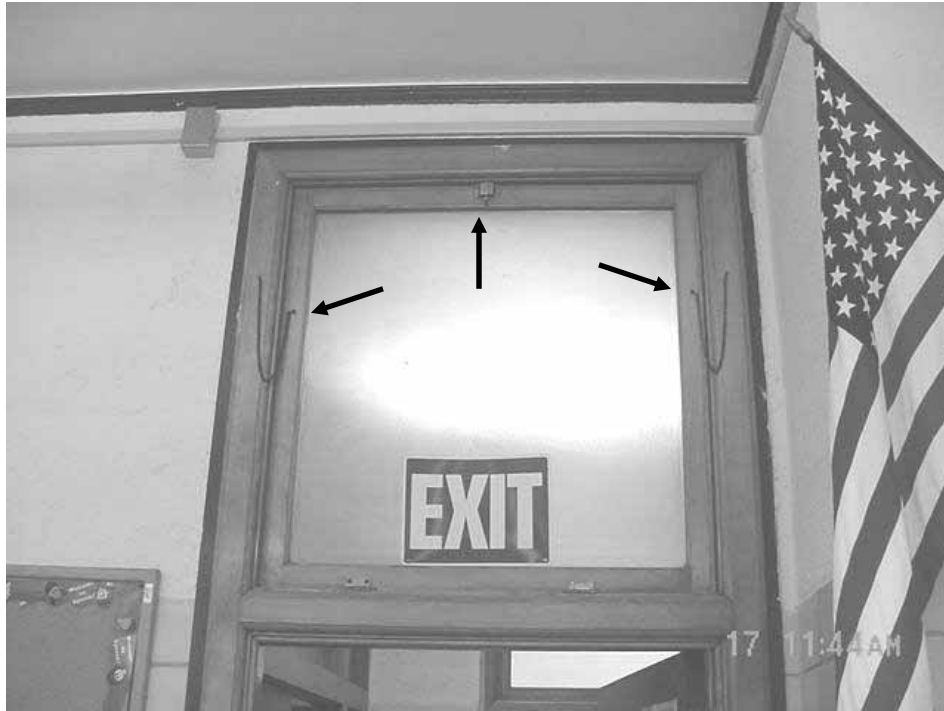
Picture 9

while maintaining a pathway for airflow. This design allows for airflow to enter an open window, pass through a classroom and subsequently pass through the open transom. Airflow then enters the hallway, passing through the opposing open classroom transom, into the opposing classroom and finally exits the building on the leeward side (opposite the windward side) (Figure 2). With all windows and transoms open, airflow can be maintained in a building regardless of the direction of the wind. This system fails if the windows or transoms are closed (Figure 3). Most of the transoms observed were inoperable and/or had hardware removed.

Transom Above Classroom Door Note Lock and Chain Mechanisms

7. Consider restoring transoms to original function to provide cross-ventilation as per the original design of the building.
8. Consider having ventilation systems re-balanced every five years by an HVAC engineering firm.

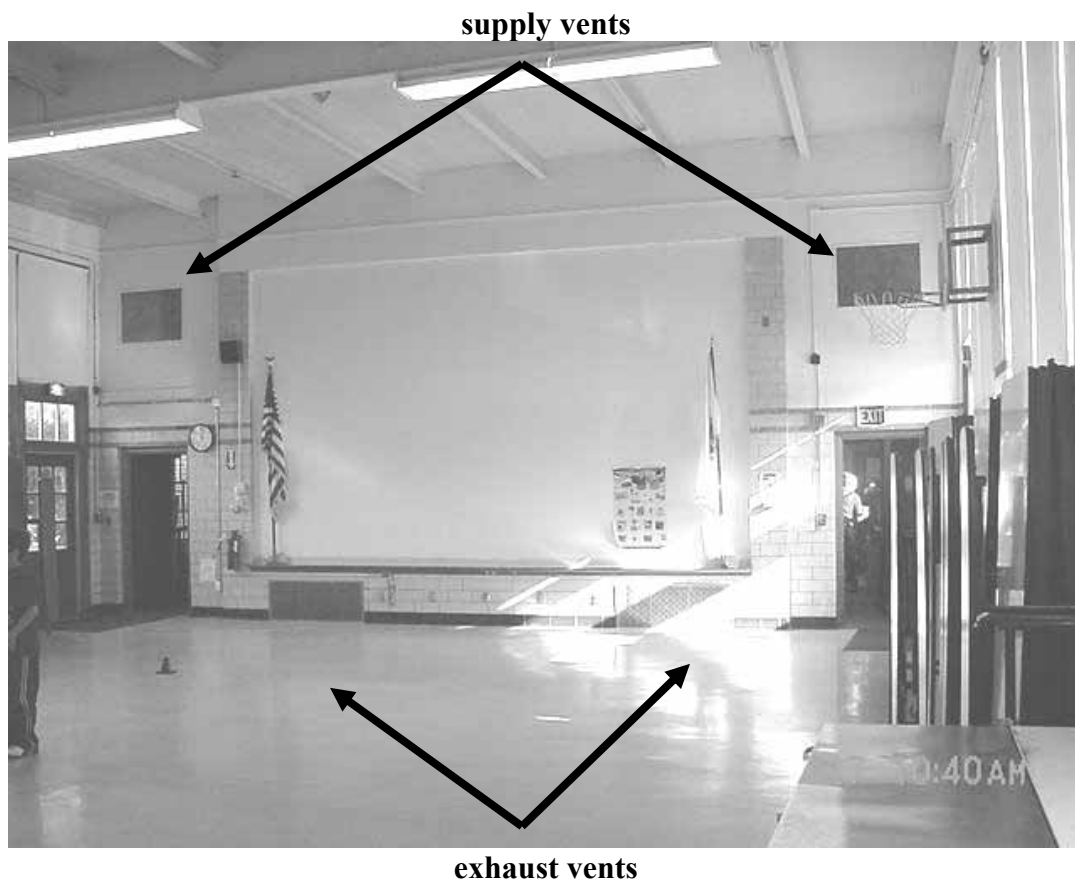
Picture 10

View of Stage and Ventilation Components

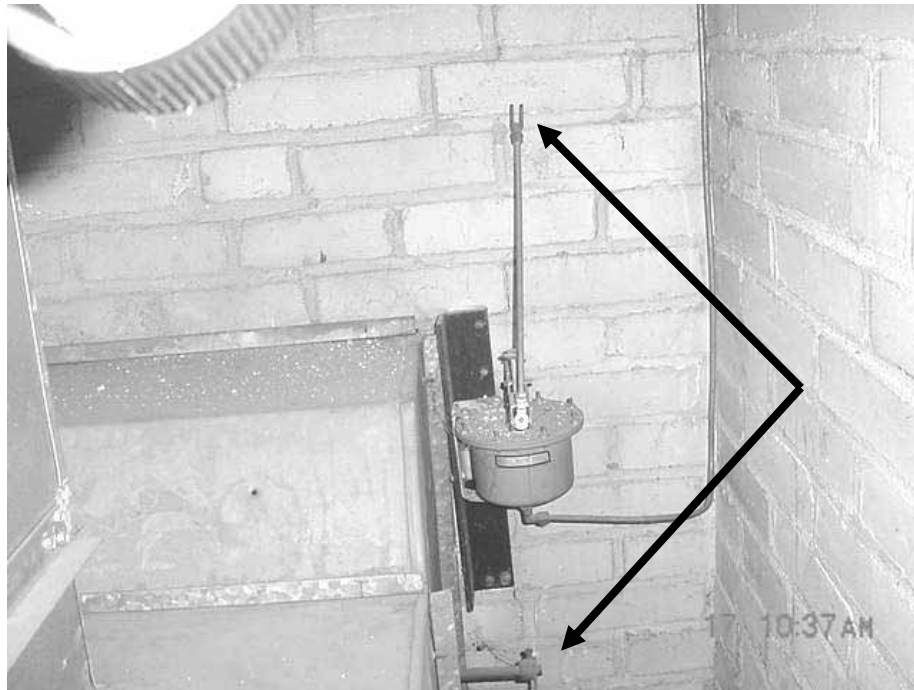
Picture 11

The cafeteria is designed to be ventilated by air handling units (AHUs). The AHUs are located in lofts flanking the stage and provide supply air through vents near the ceiling and ducted back to the AHUs via return vents on the front of the stage (Picture 10). School officials reported that only one of the AHUs routinely operates and the other one is operated as needed. The system was not operating during occupancy at the time of the assessment. MDPH staff examined the AHU in the left side loft and found the actuator bar to the fresh air intake was disconnected (Picture 11).

Disconnected Actuator Bar (to Left Side) Cafeteria AHU

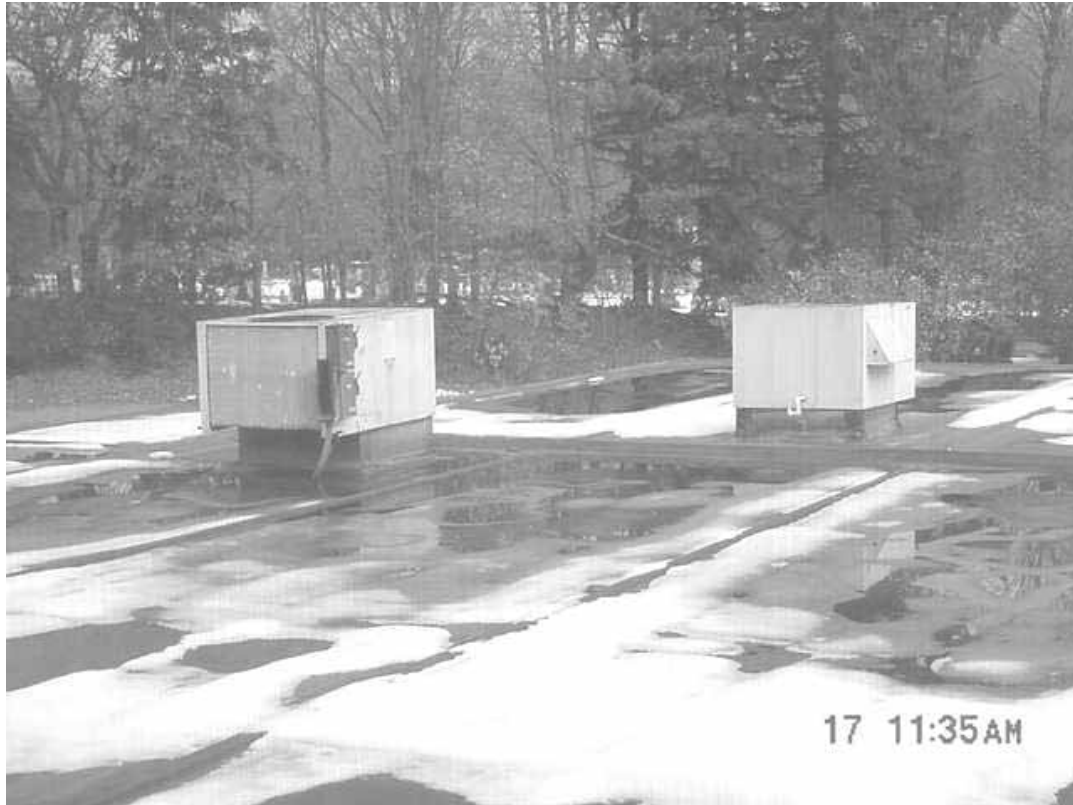
Picture 12

Ventilation for modular classrooms is provided by rooftop AHUs (Picture 12). Fresh air is distributed to classrooms via ductwork connected to ceiling-mounted air diffusers and drawn back to the units through ceiling-mounted grilles. Thermostats control each heating, ventilating and air conditioning (HVAC) system and have fan settings of “on” and “automatic”. Thermostats were set to the “automatic” setting (Picture 13) in both modular rooms surveyed during the assessment. The automatic setting on the thermostat activates the HVAC system at a preset temperature. Once the preset temperature is reached, the HVAC

Rooftop AHUs for Modular Classrooms

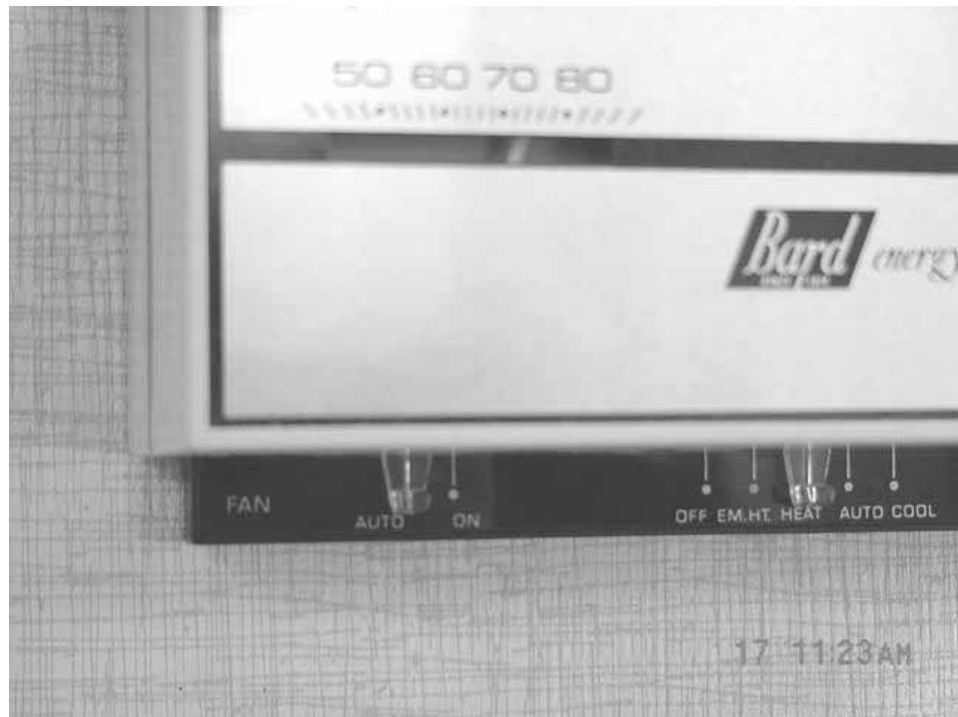
Picture 13

system is deactivated. Therefore, no mechanical ventilation is provided until the thermostat re-activates the system.

Fan Control Switch Set to the “Auto” Setting on Modular Room Thermostat

3. Set the thermostat for modular classrooms to the fan “on” position to operate the ventilation system continuously during the school day.
4. Inspect exhaust motors and belts for proper function. Repair and replace as necessary.

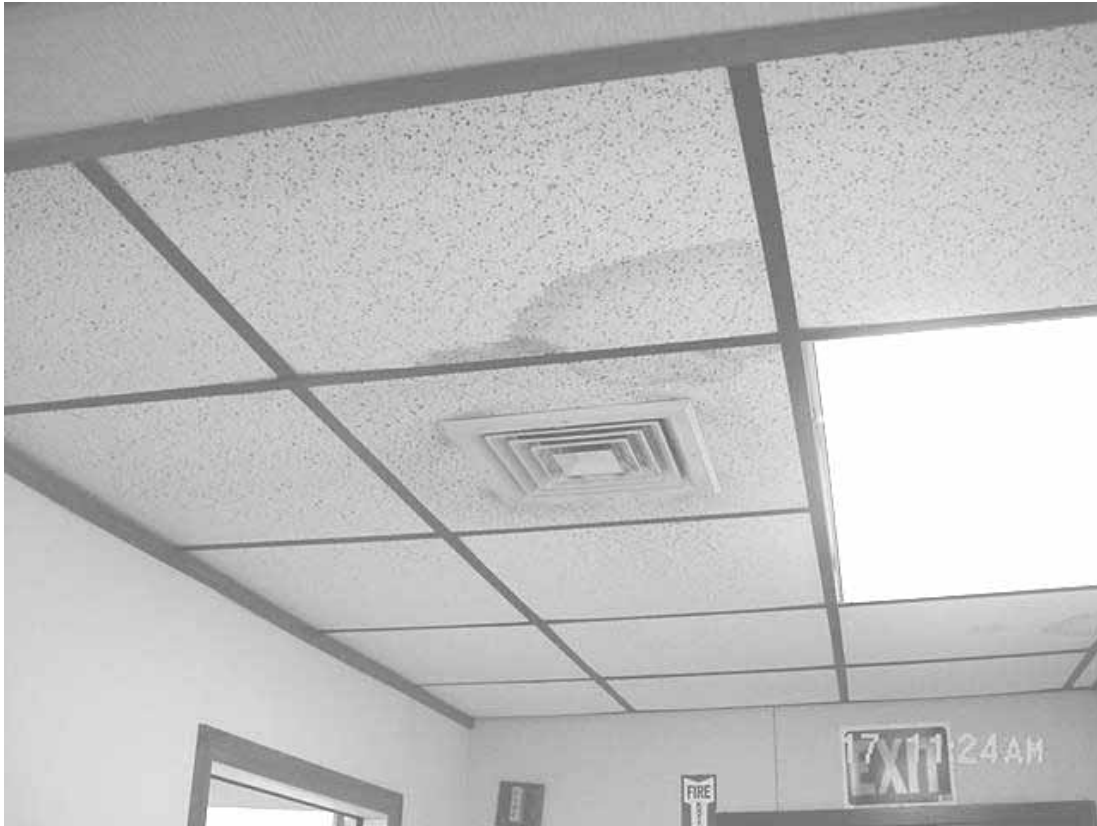
Picture 14

The building has a history of roof leaks and water damage. As discussed, a new roof was installed several months prior to the MDPH assessment. Water damaged ceiling tiles were observed in a number of areas throughout the building (Picture 14). Water-damaged ceiling tiles can provide a source of mold growth and should be replaced after a water leak is discovered and repaired. In some areas, the ceiling tile system consists of ceiling tiles adhered directly to the ceiling (Picture 15). Removal of these ceiling tiles is difficult because it necessitates the destruction of the tiles.

Water Damaged Drop Ceiling Tiles in Modular Classroom

11. Ensure roof leaks are repaired, and replace any remaining water-stained ceiling tiles (for dropped ceilings). Examine the areas above and around these tiles for mold growth. Disinfect areas of water leaks with an appropriate antimicrobial.

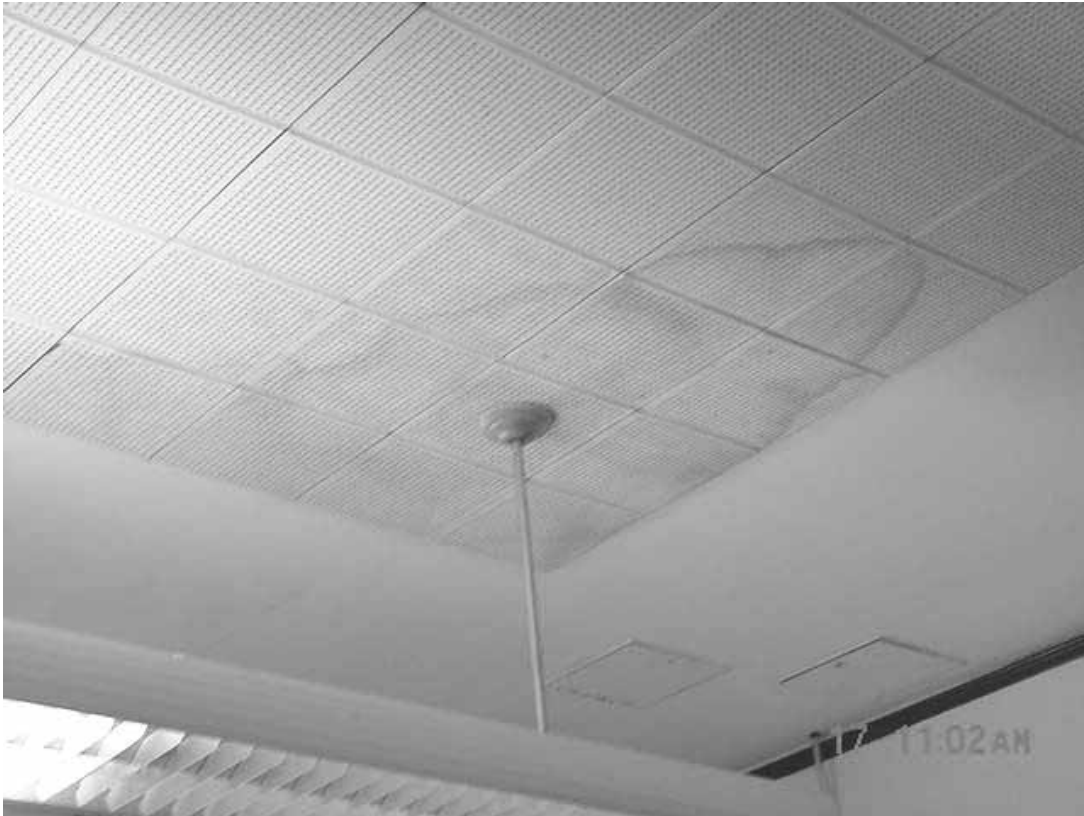
Picture 15

Water Damaged Ceiling Tiles, Note these Tiles are Adhered Directly to the Ceiling

12. For removal of tiles directly adhered to the ceiling, such removal would be considered a renovation activity that can release particulates and spores in particular, if the material is moldy. Replacement of ceiling tiles may involve glues that contain VOCs. In order to minimize occupant exposure, repairs should be done while the building is unoccupied.

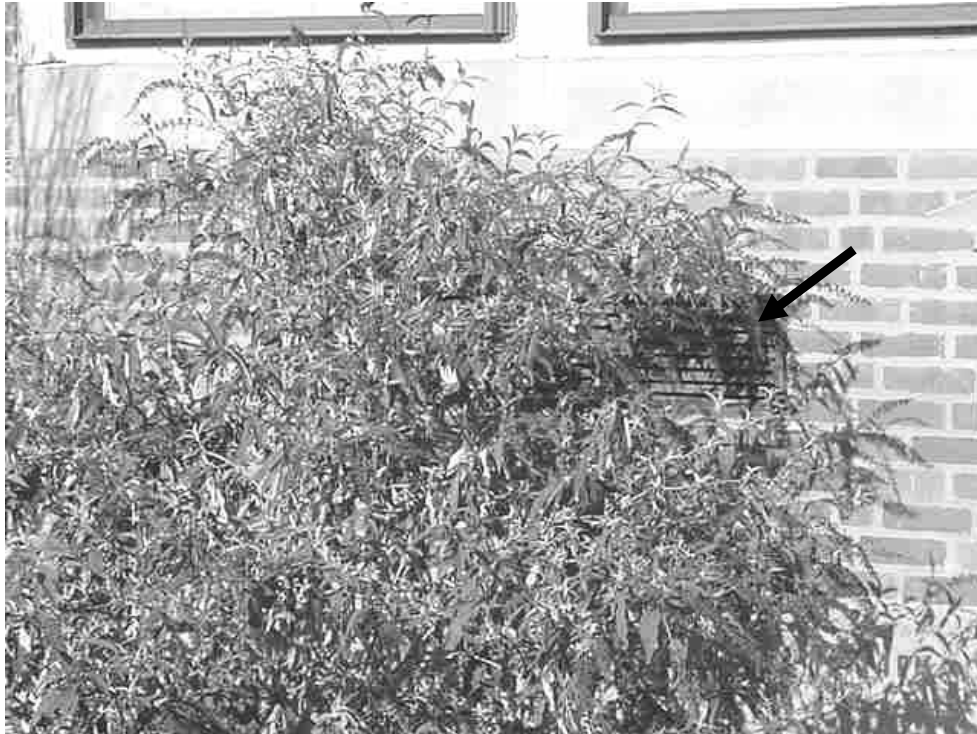
Picture 16

Around the perimeter of the building, shrubbery and other plants were observed in close proximity to univent air intakes (Picture 16), which can draw in plant debris, pollen and or mold. Several open utility holes were also observed on the exterior of the building, which can provide a means of water penetration and/or pests into the building (Picture 17). Missing/damaged gutters and downspouts were observed around the modular building

Shrubbery in Close Proximity to Univent Air Intake

13. Reinstall missing downspouts to direct rainwater away from the building.
14. Ensure univent air intakes are clear of plant growth. Remove foliage to a minimum of five feet away from the exterior of the building.

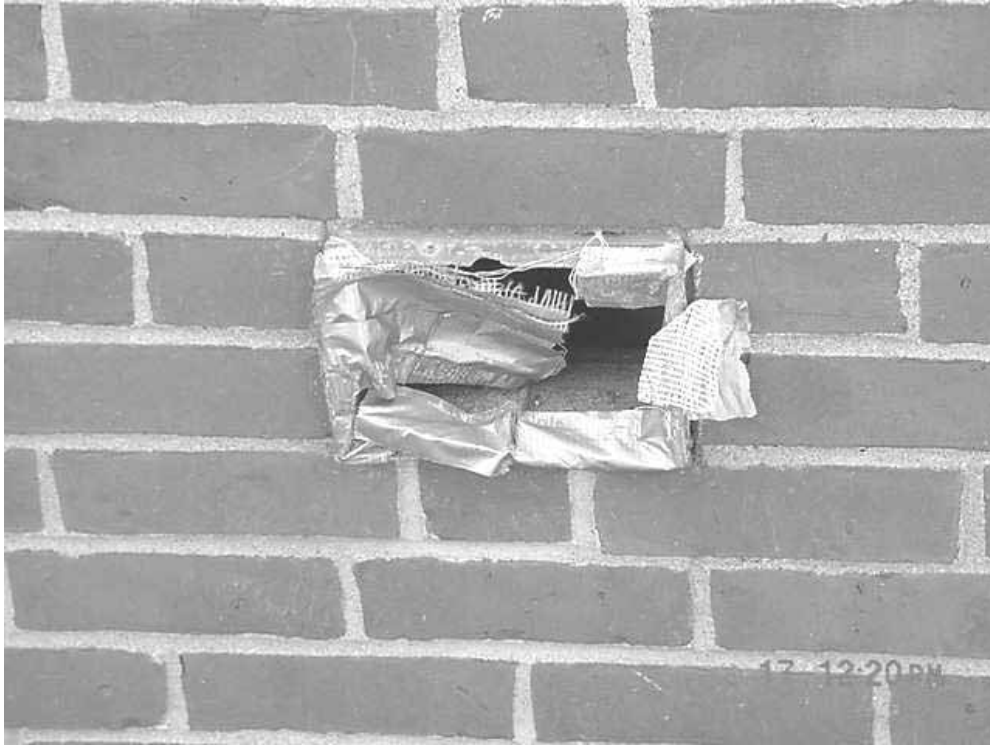
Picture 17

Open Utility Hole in Exterior Wall

15. Seal open utility holes in the building exterior to prevent water intrusion, drafts and/or pest entry.
16. Move plants away from univents in classrooms. Avoid over-watering and examine drip pans periodically for mold growth. Disinfect with an appropriate antimicrobial where necessary.

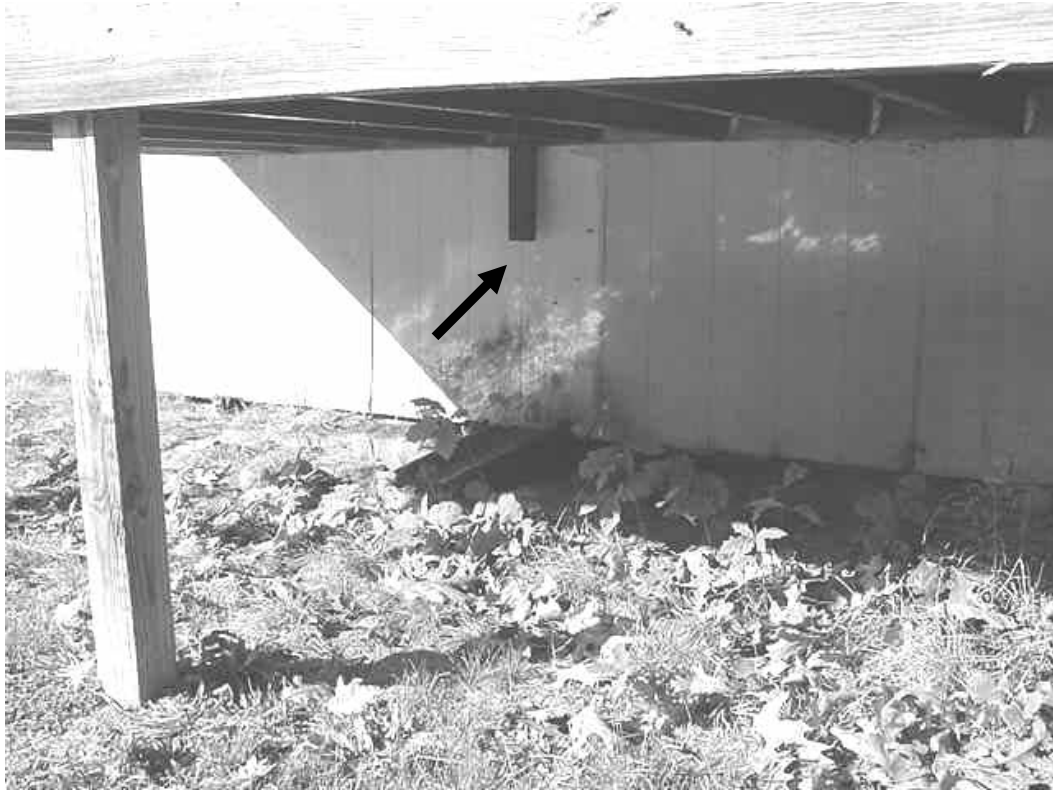
Picture 18

(Picture 18). Gutters and downspouts are designed to direct rainwater away from the base of the building.

Missing Downspout and Elbow Extension

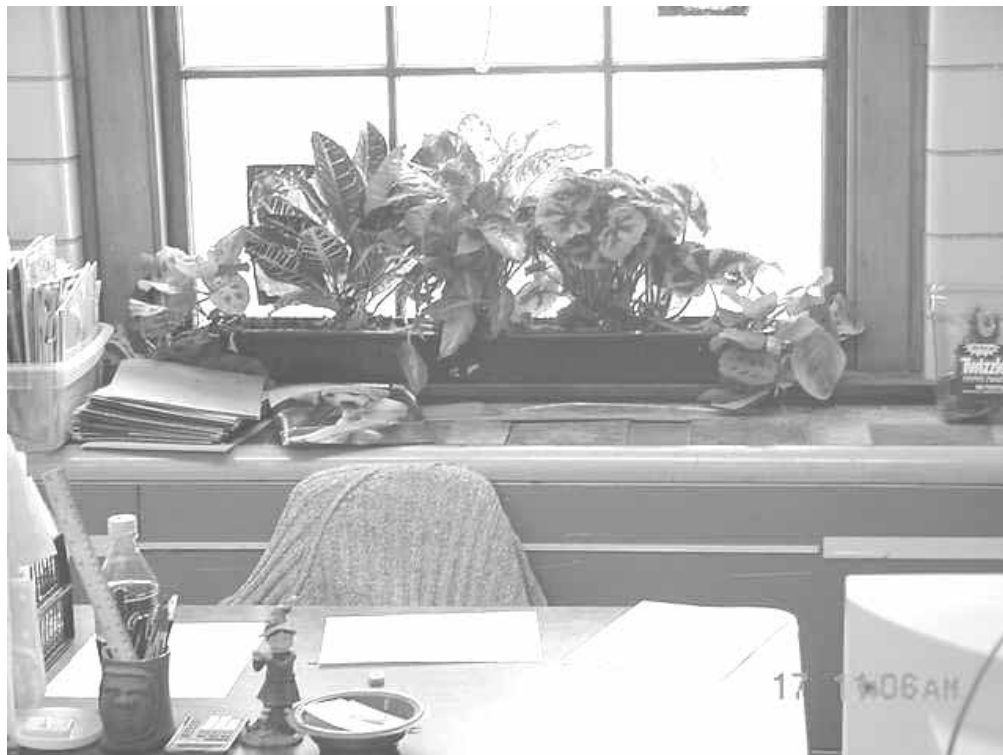
Picture 19

Plants were noted in several classrooms. Plants can be a source of pollen and mold, which can be respiratory irritants for some individuals. Plants should be properly maintained and equipped with drip pans. Plants should also be located away from univents to prevent the aerosolization of dirt, pollen or mold (Picture 19).

Plants on Top of Univent in Classroom

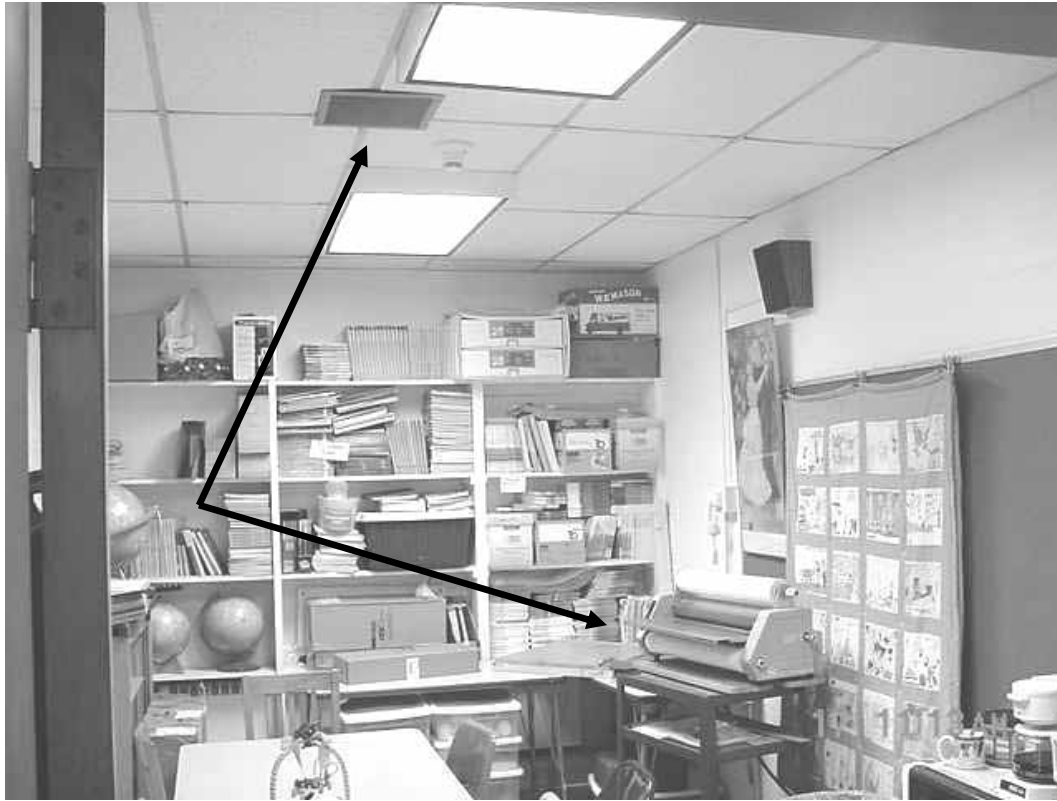
Picture 20

Please note, that the TVOC air measurements are only reflective of the indoor air concentrations present at the time of sampling. Indoor air concentrations can be greatly impacted by the use of TVOC containing products. While no measurable TVOC levels were detected in the indoor environment, VOC-containing materials were noted. Several areas contain photocopiers and lamination machines. Lamination machines can produce irritating odors during use. VOCs and ozone can be produced by photocopiers, particularly if the equipment is older and in frequent use. Ozone is a respiratory irritant (Schmidt Etkin, 1992). A local exhaust vent is located in the ceiling of the teacher's workroom (Picture 20); however, no draw was detected from this vent to help reduce excess heat and odors.

Lamination Machine and Ceiling Exhaust Vent in Teachers Workroom

9. Consider installing mechanical exhaust ventilation in the kitchen and copy room to remove excess heat and pollutants.
10. For buildings in New England, periods of low relative humidity during the winter are often unavoidable. Therefore, scrupulous cleaning practices should be adopted to minimize common indoor air contaminants whose irritant effects can be enhanced when the relative humidity is low. To control for dusts, a high efficiency particulate arrestance (HEPA) filter equipped vacuum cleaner in conjunction with wet wiping of all surfaces is recommended. Avoid the use of feather dusters. Drinking water during the day can help ease some symptoms associated with a dry environment (throat and sinus irritations).

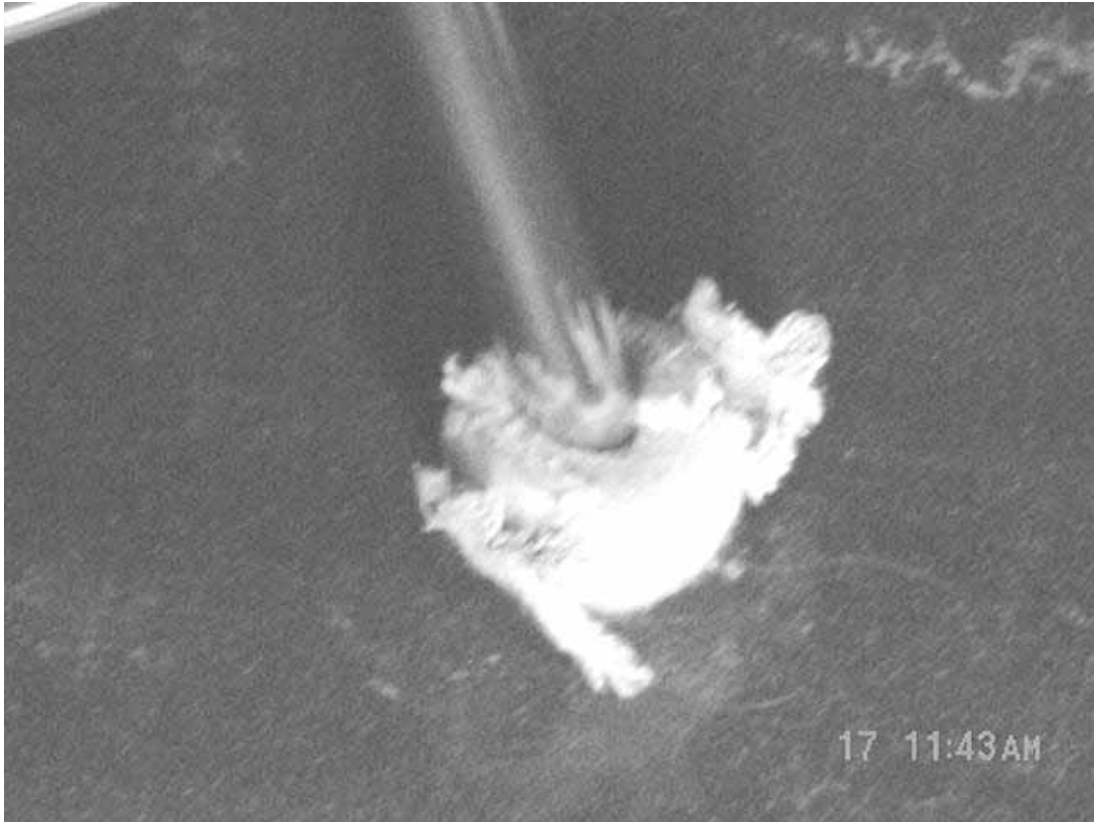
Picture 21

In an effort to reduce noise from sliding chairs, tennis balls had been sliced open and placed on chair legs (Picture 21). Tennis balls are made of a number of materials that are a source of respiratory irritants. Constant wearing of tennis balls can produce fibers and off-gas TVOCs. Tennis balls are made with a natural rubber latex bladder, which becomes abraded when used as a chair leg pad. Use of tennis balls in this manner may introduce latex dust into the school environment. Some individuals are highly allergic to latex (e.g., spina bifida patients) (SBAA, 2001). It is recommended that the use of materials containing latex be limited in buildings to reduce the likelihood of symptoms in sensitive individuals (NIOSH, 1997). A question and answer sheet concerning latex allergy is attached as [Appendix B](#) (NIOSH, 1998).

Frayed Tennis Ball on Chair Leg in Classroom

20. Consider discontinuing the use of tennis balls on walker legs to prevent latex dust generation. Alternative “glides” can commonly be purchased from office supply stores, see Picture 22 for an example.
